Selkirk Flood Protection Scheme

Long Philip Burn River Restoration

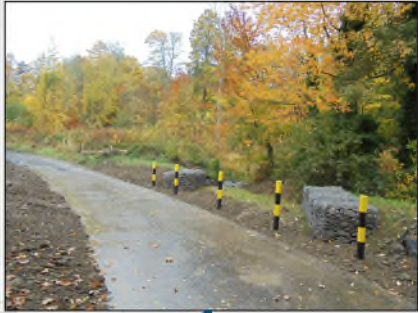
New overflow spillway which during very high flow events will divert excess flow onto Corby Linn Road, protecting Ravensheugh House from flooding

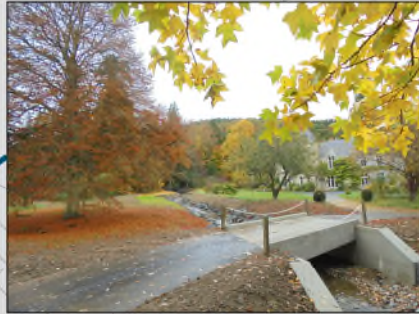
Burn restoration and new reinforced concrete bridge

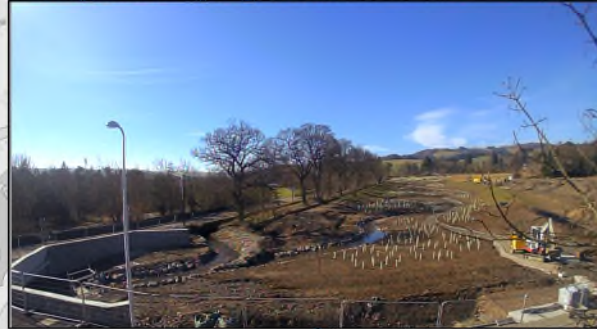
Flood wall, flood embankment and re-meandered burn next to Bannerfield playpark

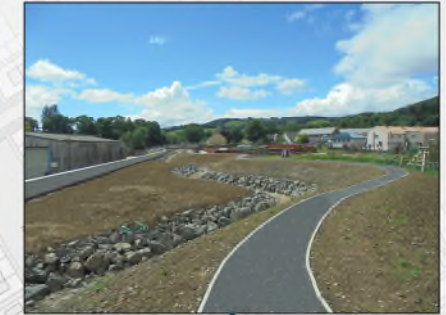
New ramp and channel to redirect excess flow back into the burn

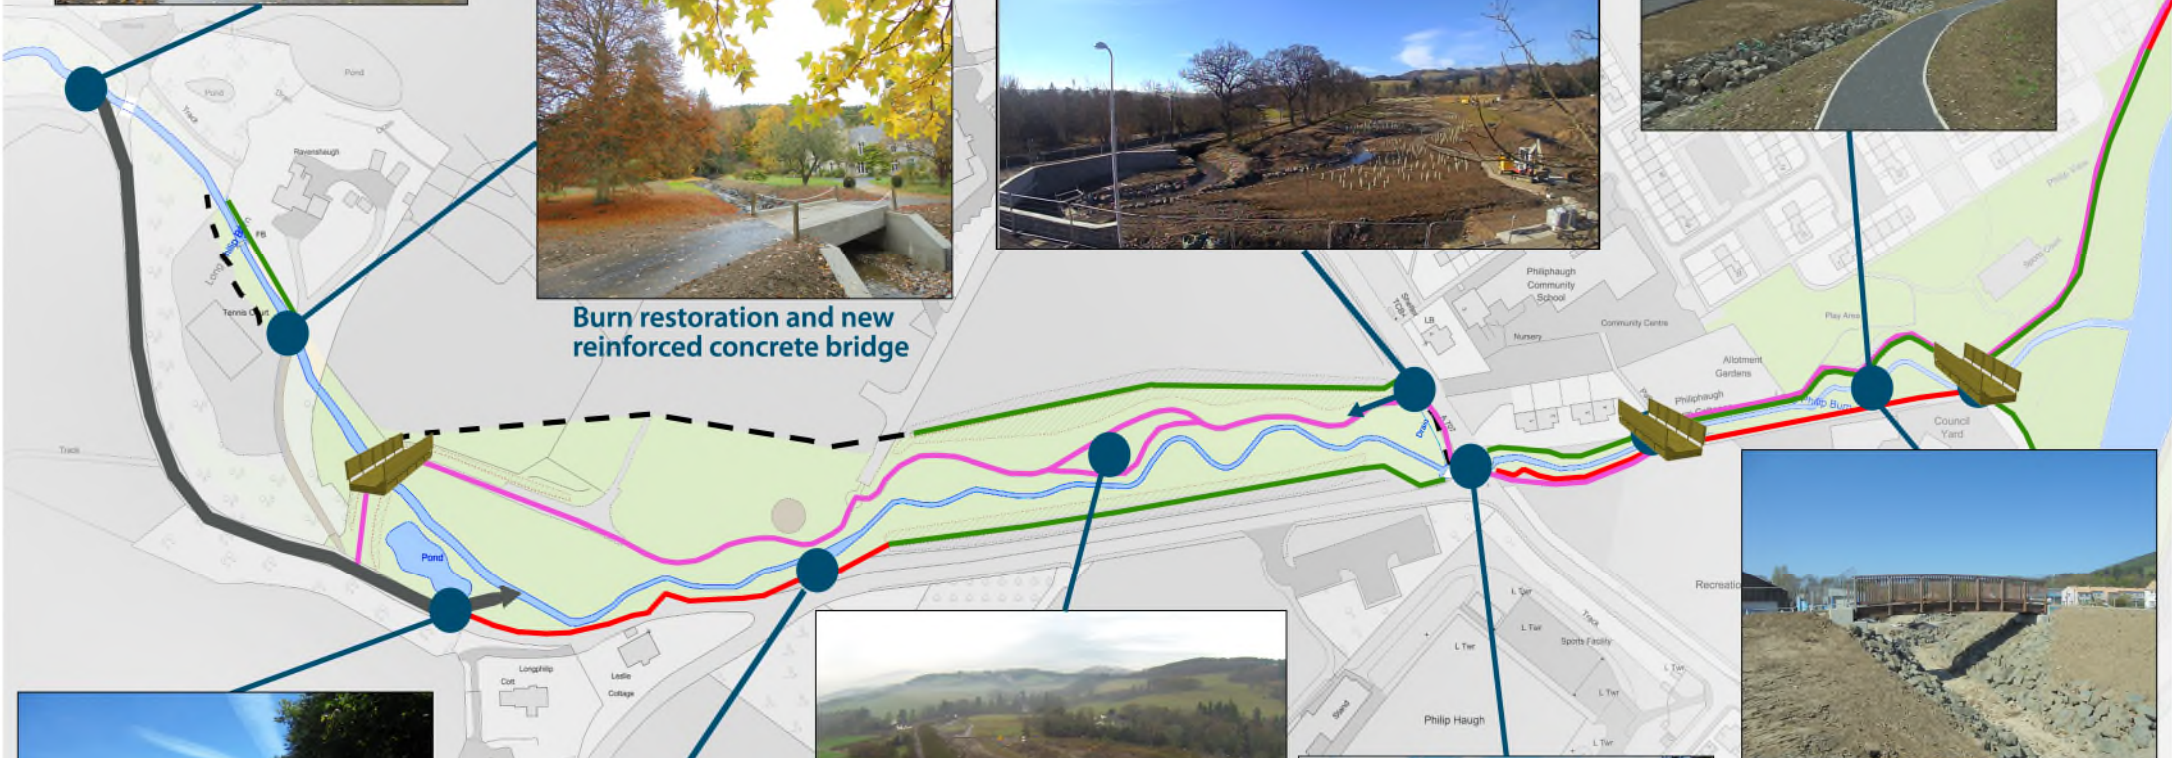
- Flood Defence Embankment
- Flood Defence Wall
- - - Ground Re-engineering
- New or upgraded footpath

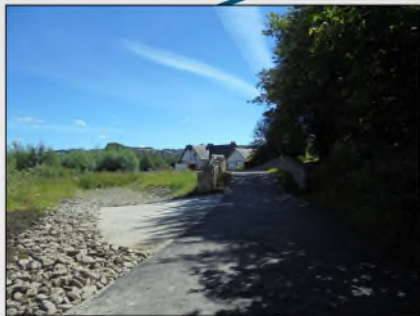
Old bridge demolished at the eastern end of Corby Linn Road

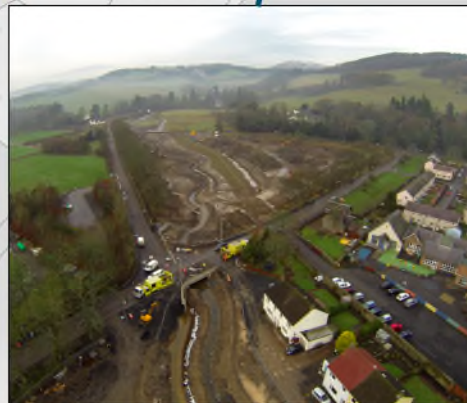
Angles Field flood embankments, re-meandered burn and new A707/A708 junction during construction

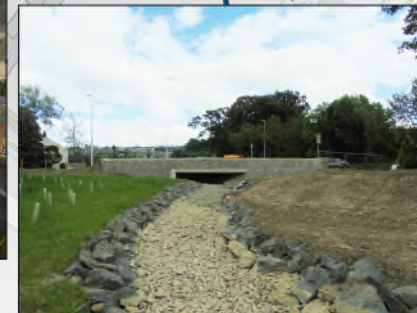
New reinforced concrete bridge and improved A707/A708 junction

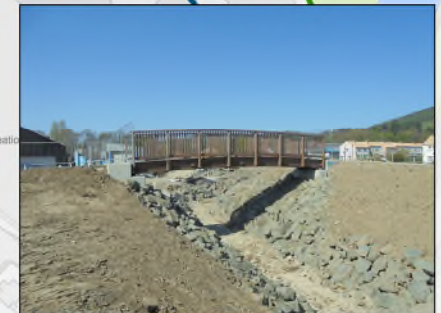
3 new Ekki timber footbridges raised above the 1 in 200 years flood level. Can remain open during high flow events
